approach

approach/march 1967

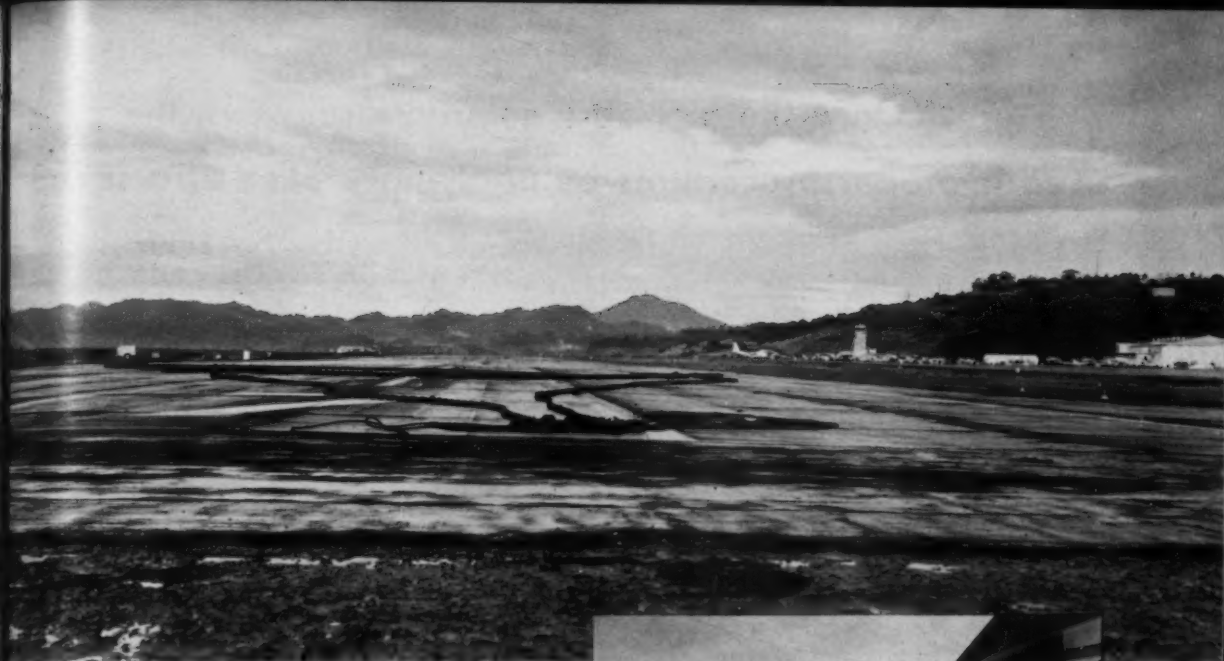
At 140 kts the F-4's tail hook engaged the chain gear and all hell broke loose. . .

Once the aircraft was on the runway, the pilot used improper procedures by applying brakes at a speed far in excess of the 90 kts recommended by NATOPS.

The recommendations were: "Aerodynamic braking should not be commenced while aircraft still has flying speed. Once a waveoff has been initiated, a subsequent abort should be avoided if it is possible to get airborne safely. In executing an abort, where engagement of the abort or barrier gear is anticipated, the importance of securing the engine and lowering the hook as rapidly as possible should be reemphasized. The importance of engaging MA-1A barrier gear on or near centerline going straight should be reemphasized."

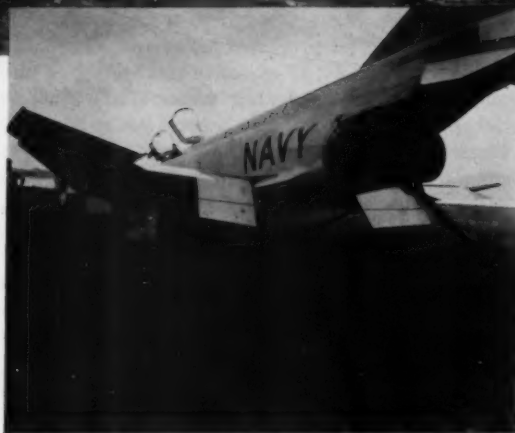
. . . The *Phantom II* came to a halt on its nose in the dirt.

NATOPS instructions for the F-4 landing on a wet runway states: "A wet runway landing should be made at a normal landing gross weight of 31,000 lbs. (this F-4 was estimated to gross out at 35,000 on the first waveoff). Fly a normal approach with an 'on-speed' or slightly lower indexer indication. The drag chute should be deployed on touchdown and the flaps should be left in the DOWN position. To further decrease thrust it is recommended that the left engine be shut down. Light braking can be initiated at 100 kts CAS. Be prepared to engage the arresting gear if the aircraft is not slowing down properly. *Lower the tail hook at least 1000 ft ahead of the wires; five seconds are required for full extension.*"

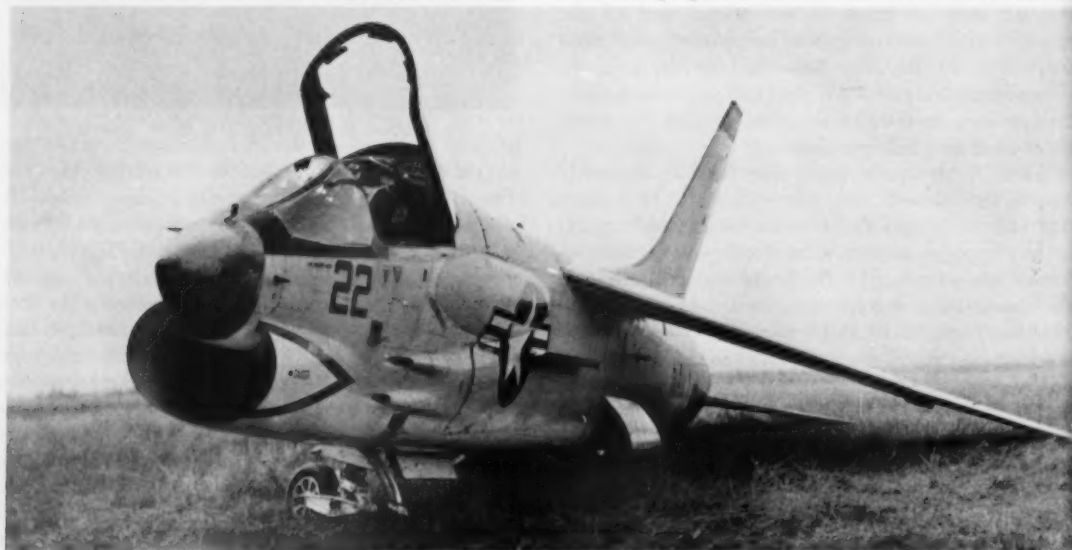
The *Crusader* came to rest short of a cliff.

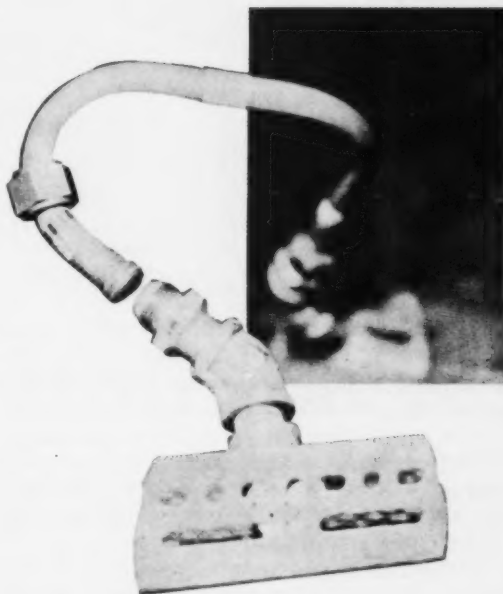
Tubing nut must not be used to pull assembly into place. Always call a specialist to adjust it correctly.

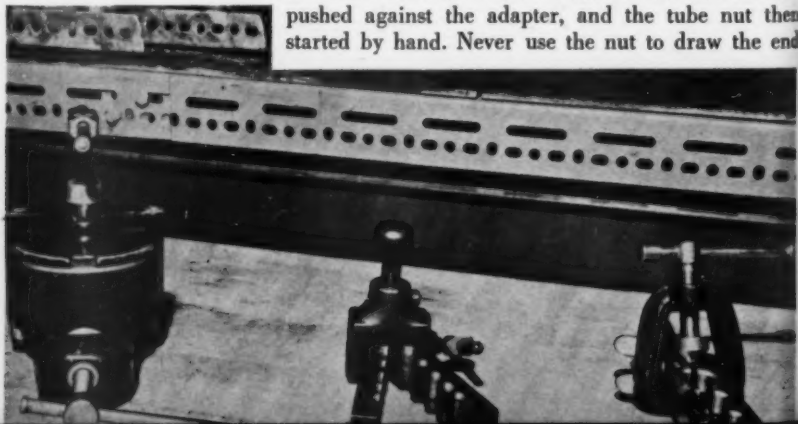
Commercial type of auto flaring tools below, far right, should not be used in plumbing maintenance.

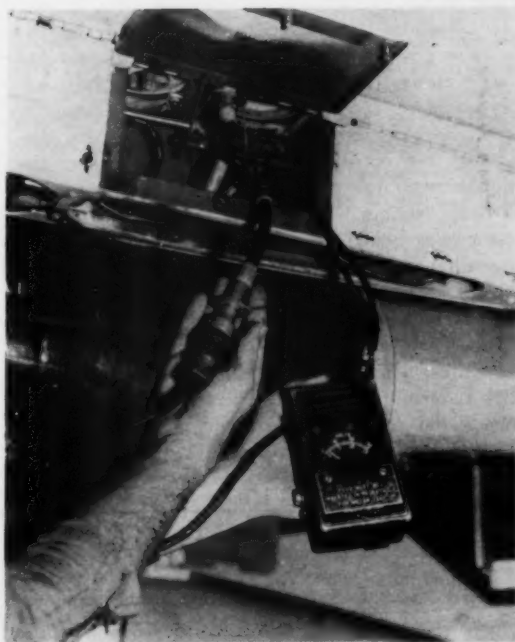
Correct: Tester lead connected to aircraft rocket circuit. Thumb actuates switch controlling volt meter. Bailwire on aircraft circuit connector is disconnected for photo purposes.

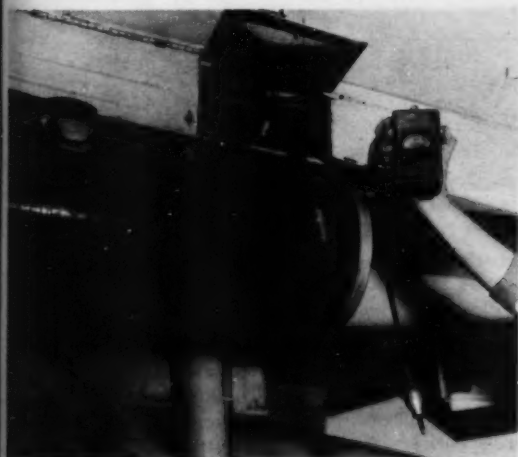
Investigation revealed the AO had been instructed on stray voltage check procedures just the day before. The adapter cable from the aircraft was the only item that should have been connected to the tester to check for stray voltage in the aircraft's system but the AO thought he was also supposed to connect and check the pigtail from the rocket pack. Application of tester voltage while conducting a stray voltage check indicates a complete lack of understanding

Incorrect: With tester connected to rocket pigtail and by depressing self-test switch (note thumb) voltage is directed to rocket causing firing.

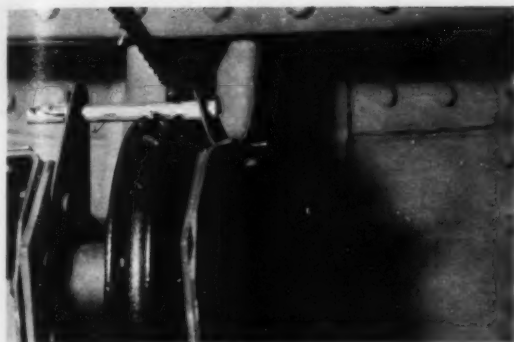
Misrouted cable

A MAINTENANCE booby trap was discovered after five flights following an SH-3A Calendar Inspection. The rudder/rotor cable was found with 2 broken strands and over 50 percent of the wires in the remaining strands broken over a three-inch area at the pulley.

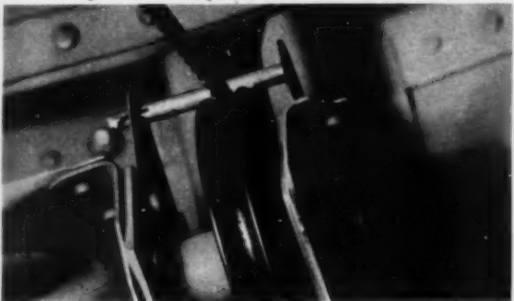
Correct cable routing

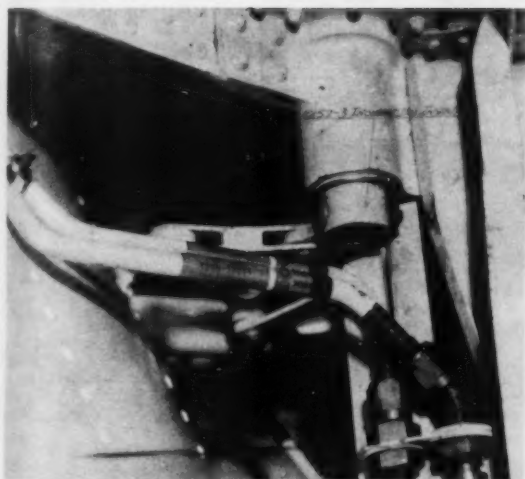
Incorrect—Arm assembly reversed and mispositioned 180 degrees

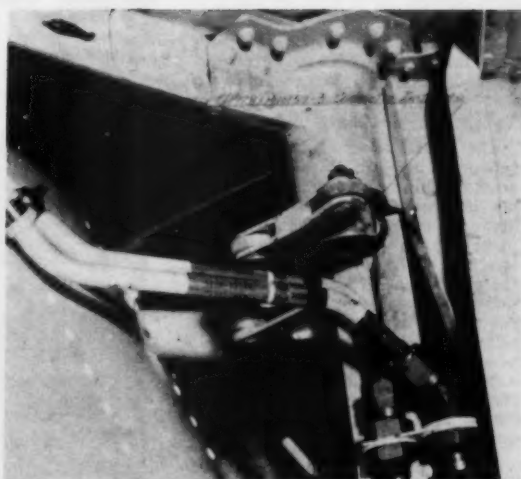
Correct—Arm assembly positioned properly

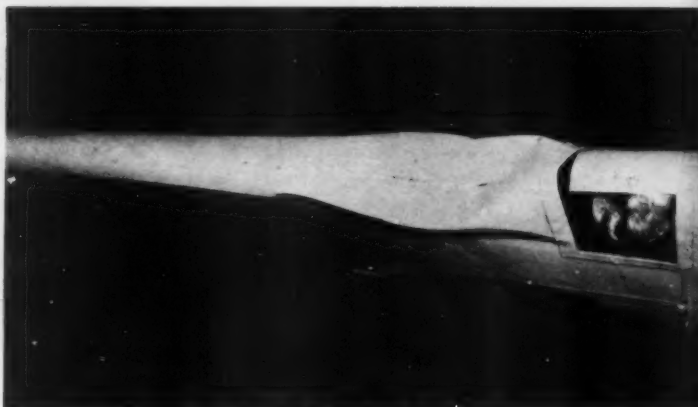
T-34 after encounter with bird.

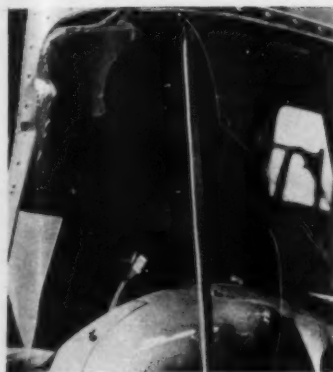
Bird damage to CH-19E.
